# Smoke and Dye Testing Summary

## High Level Sewershed

Test ID	Test Type	Date Inspected	Company / Super.	Blower MH	Ground Condition	Notification Made?	Total Length
S1028-251	Smoke	8/27/2009	ADS/TM	S21QQ_004MH	Dry	Yes	601.30

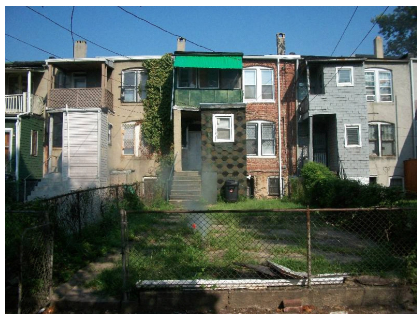
**Picture** \S1028-251-OB01-P01.jpg

**Source** Cleanout

**Location** Yard - back

**Comments** Smoke from cleanout in back yard. 2319 Bryant Ave.

**Comments** Back of house, 2319 Bryant Ave.

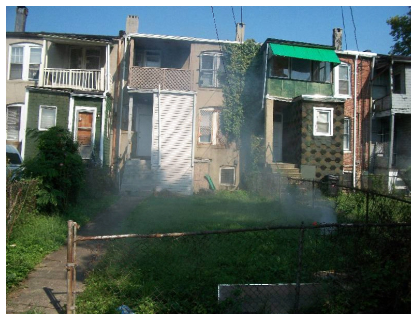
**Picture** \S1028-251-OB02-P01.jpg

**Source** Cleanout

**Location** Yard - back

**Comments** Smoke from cleanout in back yard. 2317 Bryant Ave.

**Comments** Back of house, 2317 Bryant Ave.

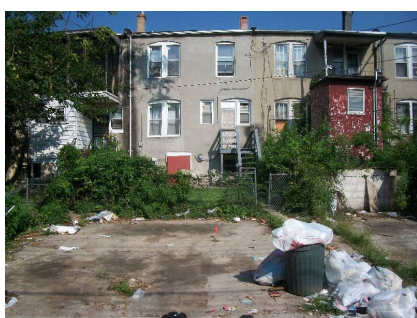
**Picture** \S1028-251-OB03-P01.jpg

**Source** Cleanout

**Location** Paved concrete

**Comments** Smoke from cleanout in paved concrete behind house. 2311 Bryant Ave.

**Comments** Back of house, 2311 Bryant Ave.
